**APPENDIX F**  
**MERCED RIVER PRIORITY SITES**

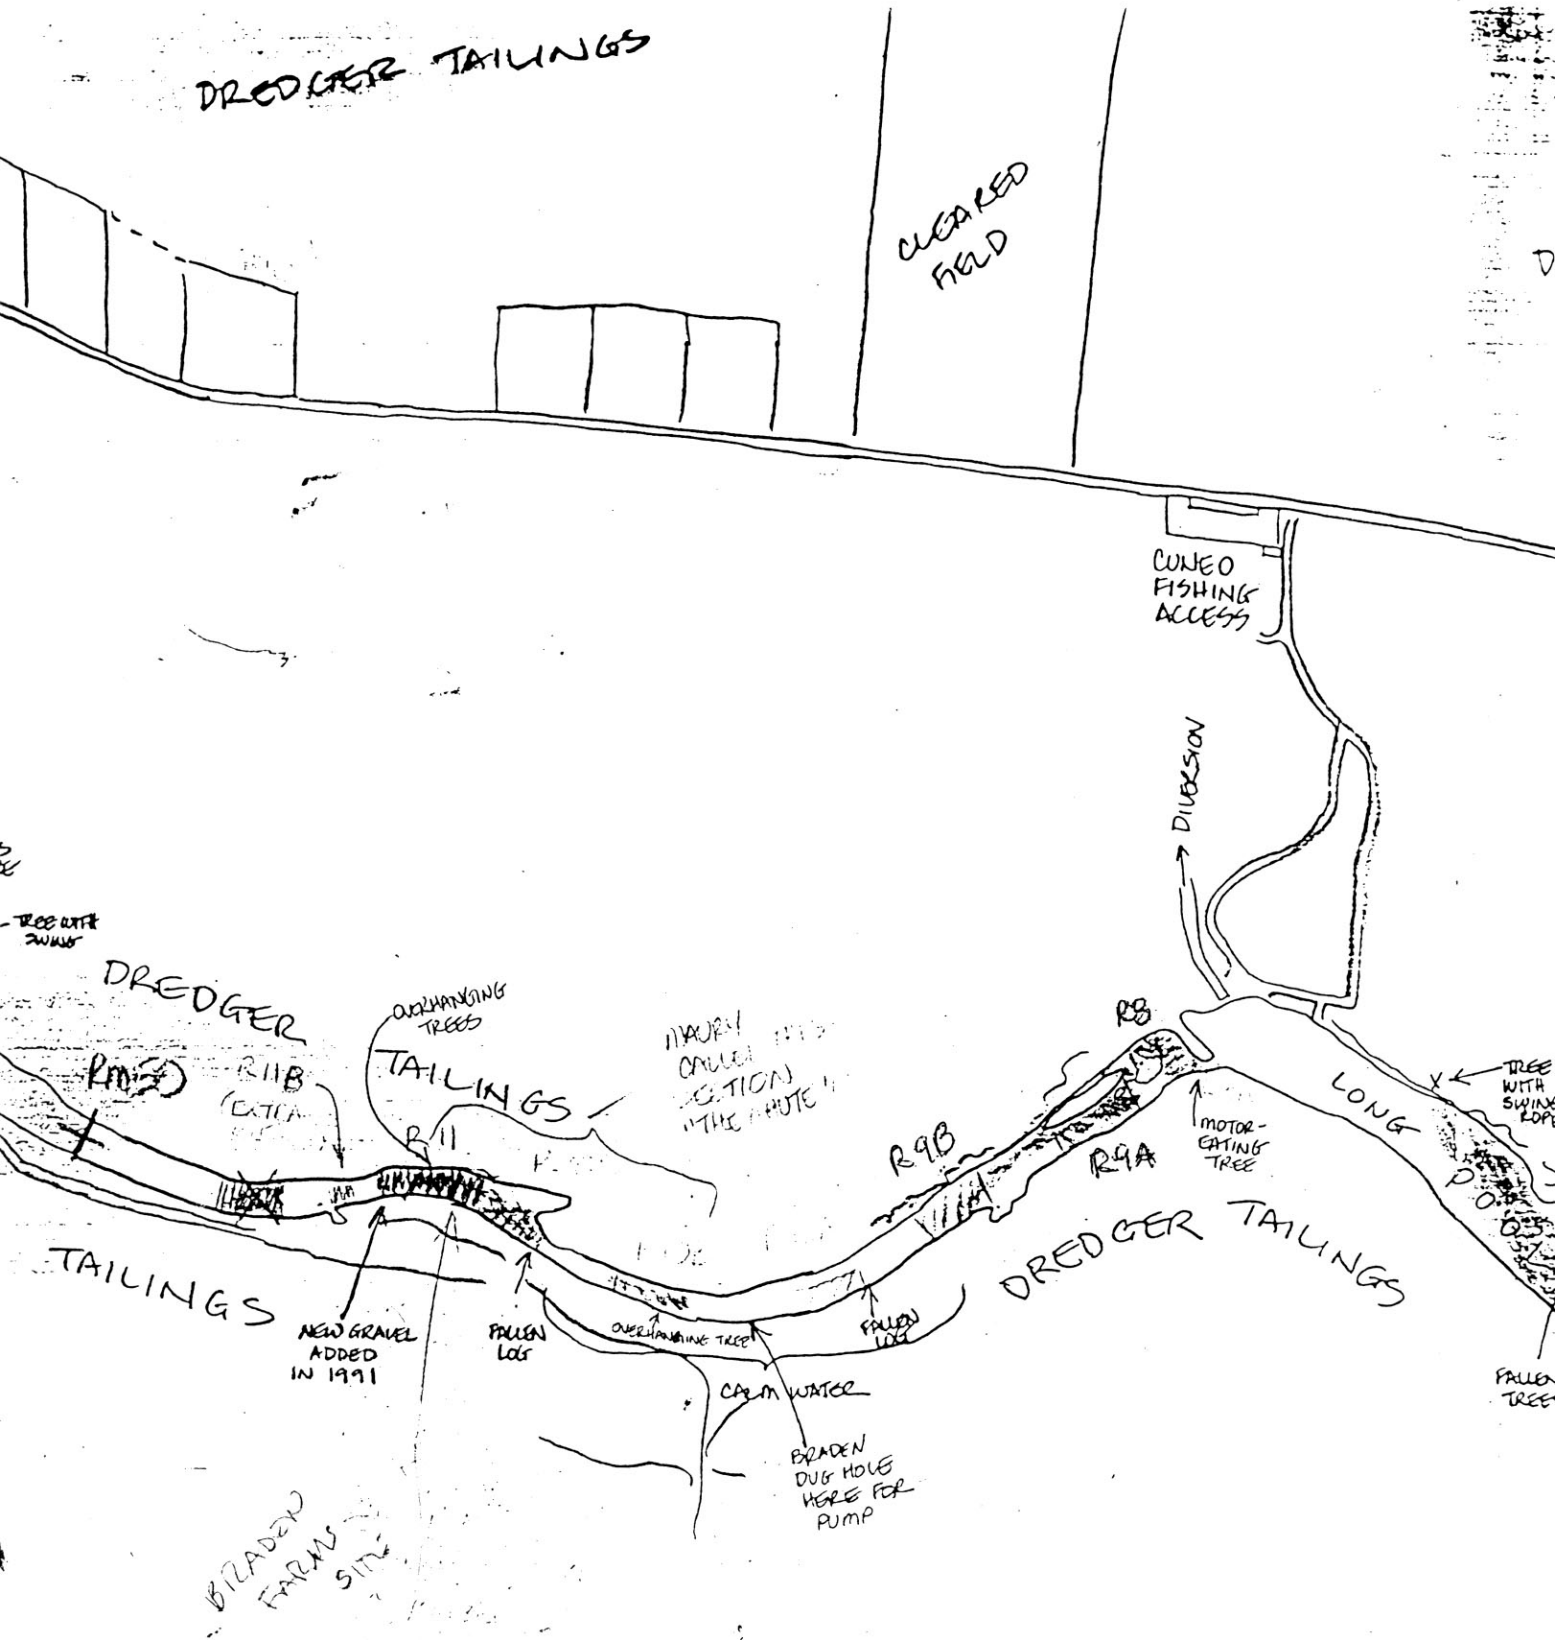
**Merced River**  
**Mile 50.4**  
**Riffle 8**

There is a split flow and a diversion structure at this site. The substrate is large, armored cobble. The site is approximately 300 feet long and 75 feet wide, with a drop of 1.5 to 2 feet. There is good overhanging riparian vegetation along the banks and easy access off of Merced Irrigation District road on the north.

Restoration would involve excavating the substrate and replacing it with graded, washed spawning gravel.

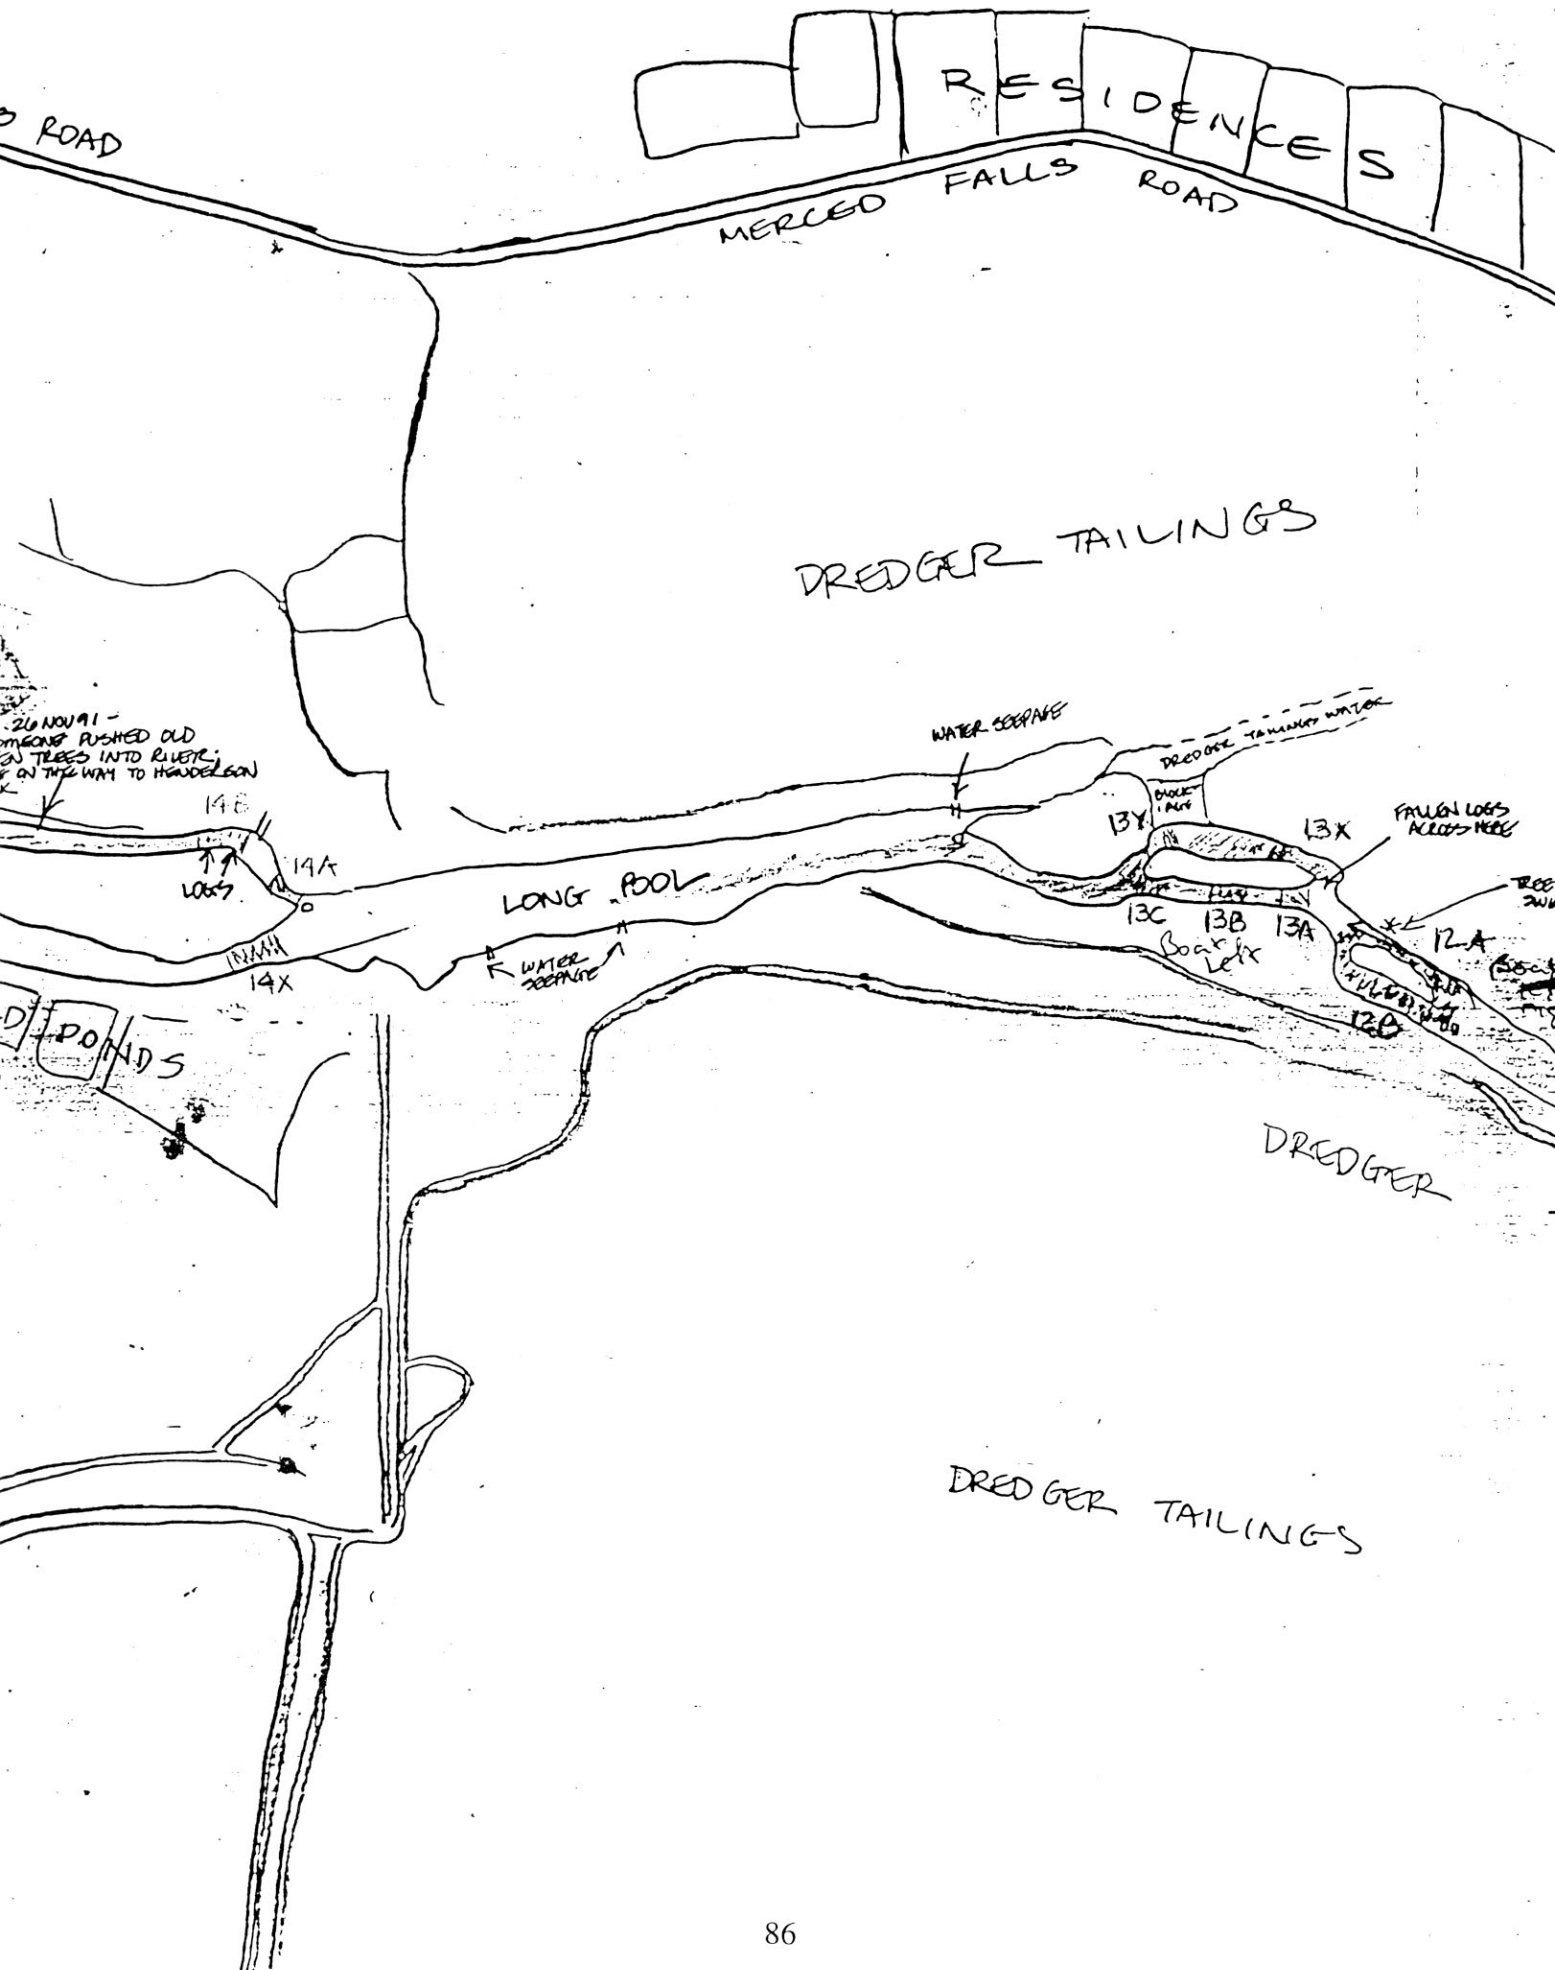
**Merced River**  
**Mile 49.9**  
**Riffles 12A, 12B, 13A, 13B, and 13C**

There are two islands in the channel at this location. The hydrology at this site provides ample opportunities to create habitat diversity. Restoration would involve excavating the substrate and replacing it with graded, washed spawning gravel. Riffles 13X and 13Y in the north channel are used by spawning salmon. No restoration of these two riffles is proposed.

The site is approximately 800 feet long altogether. The site has good access from dredger roads on the south side.

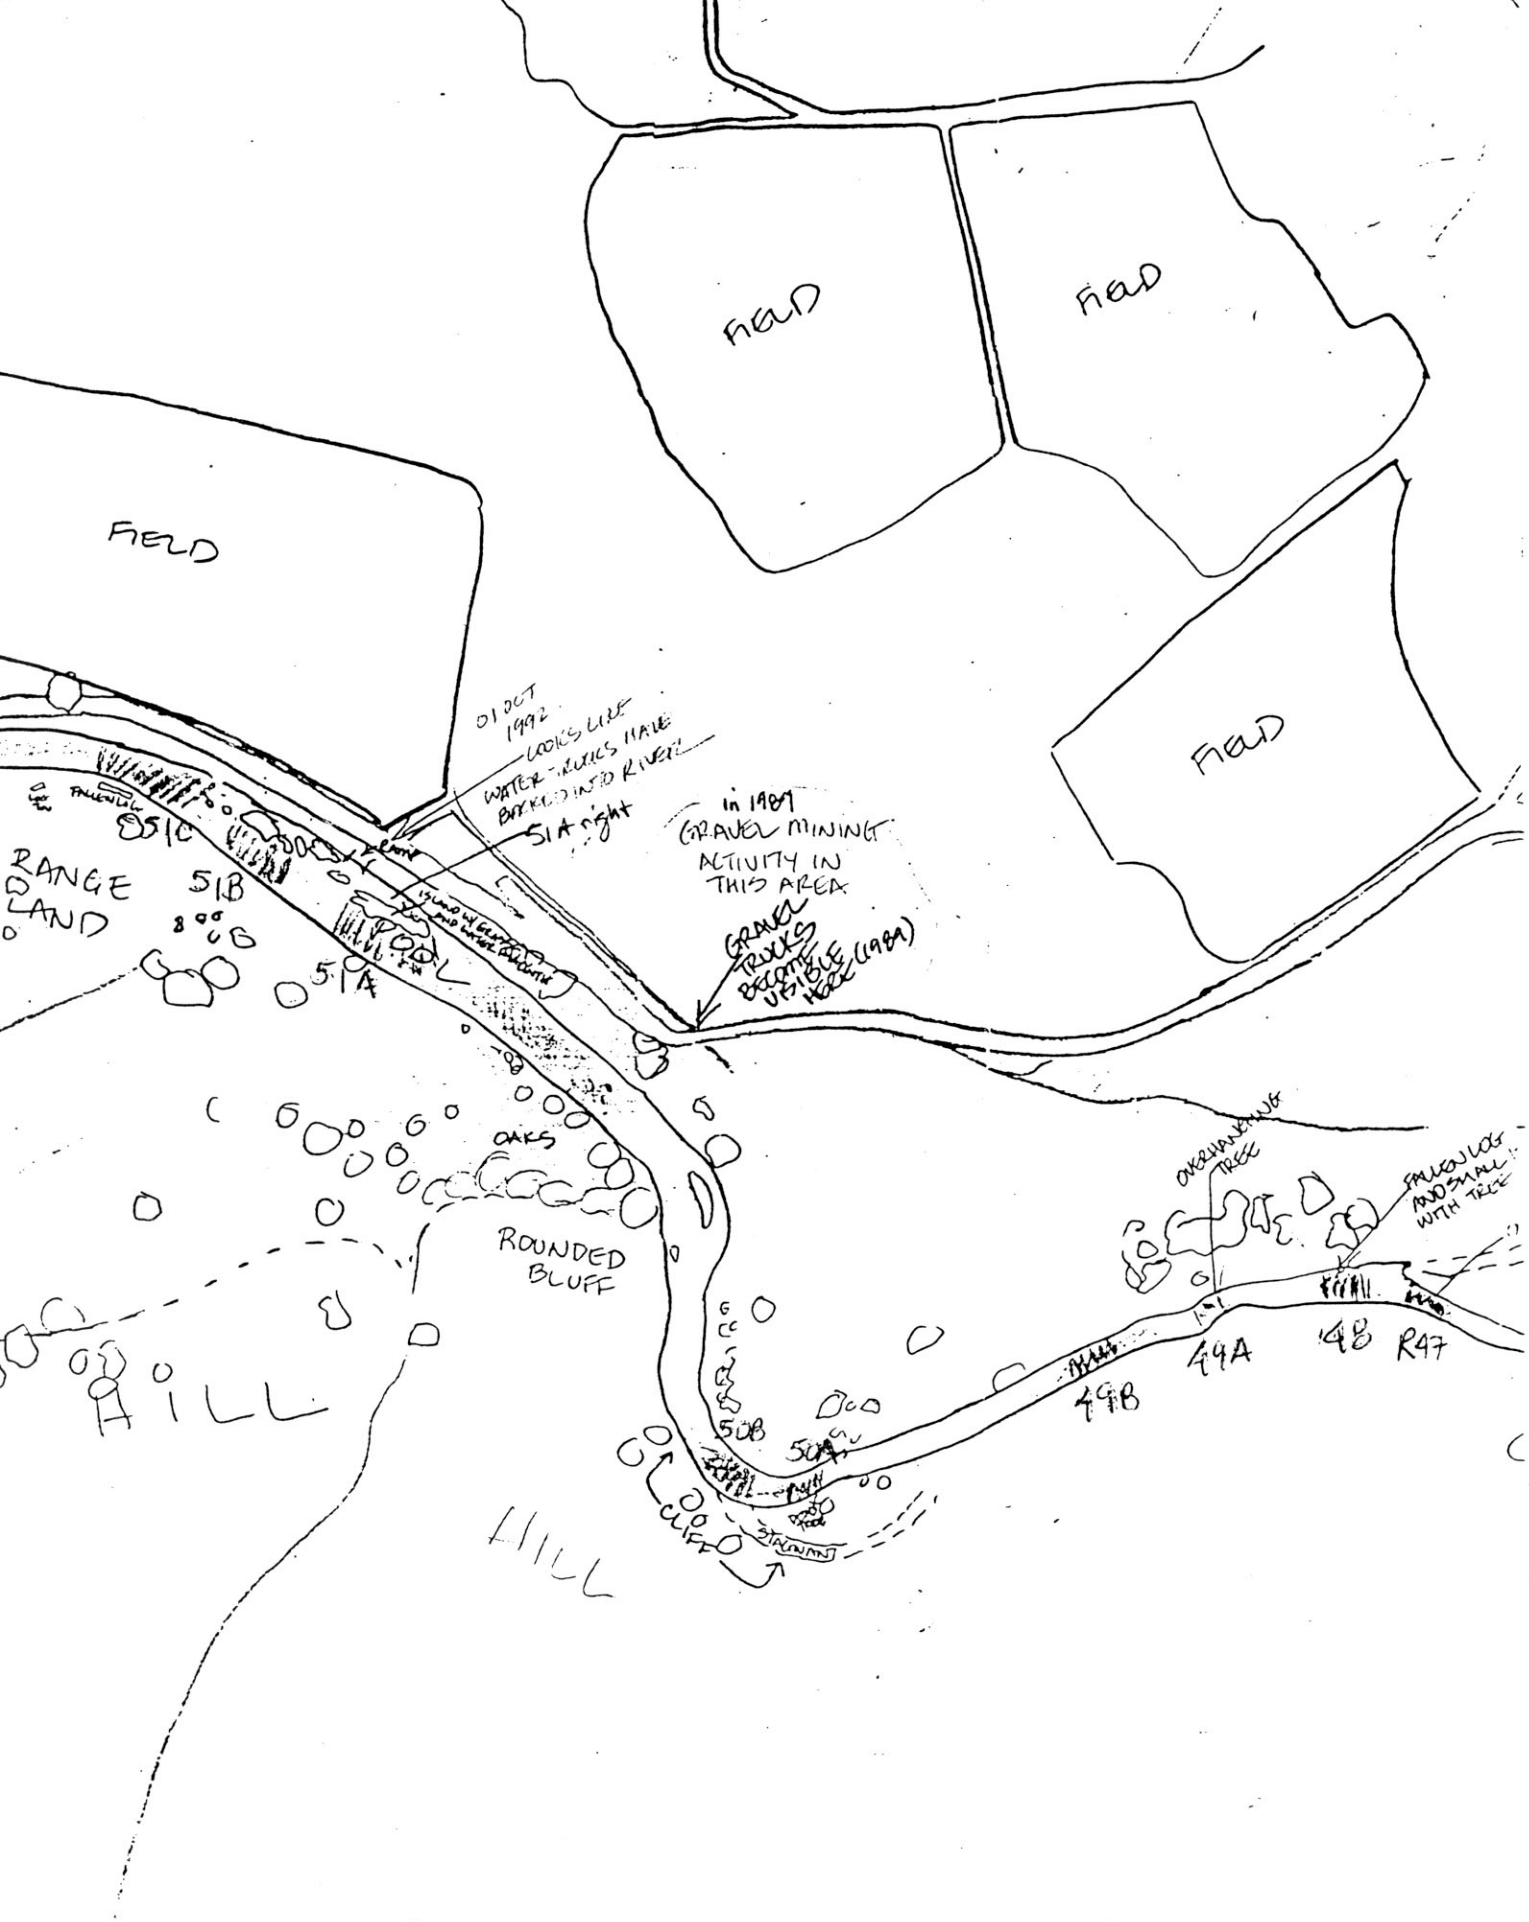
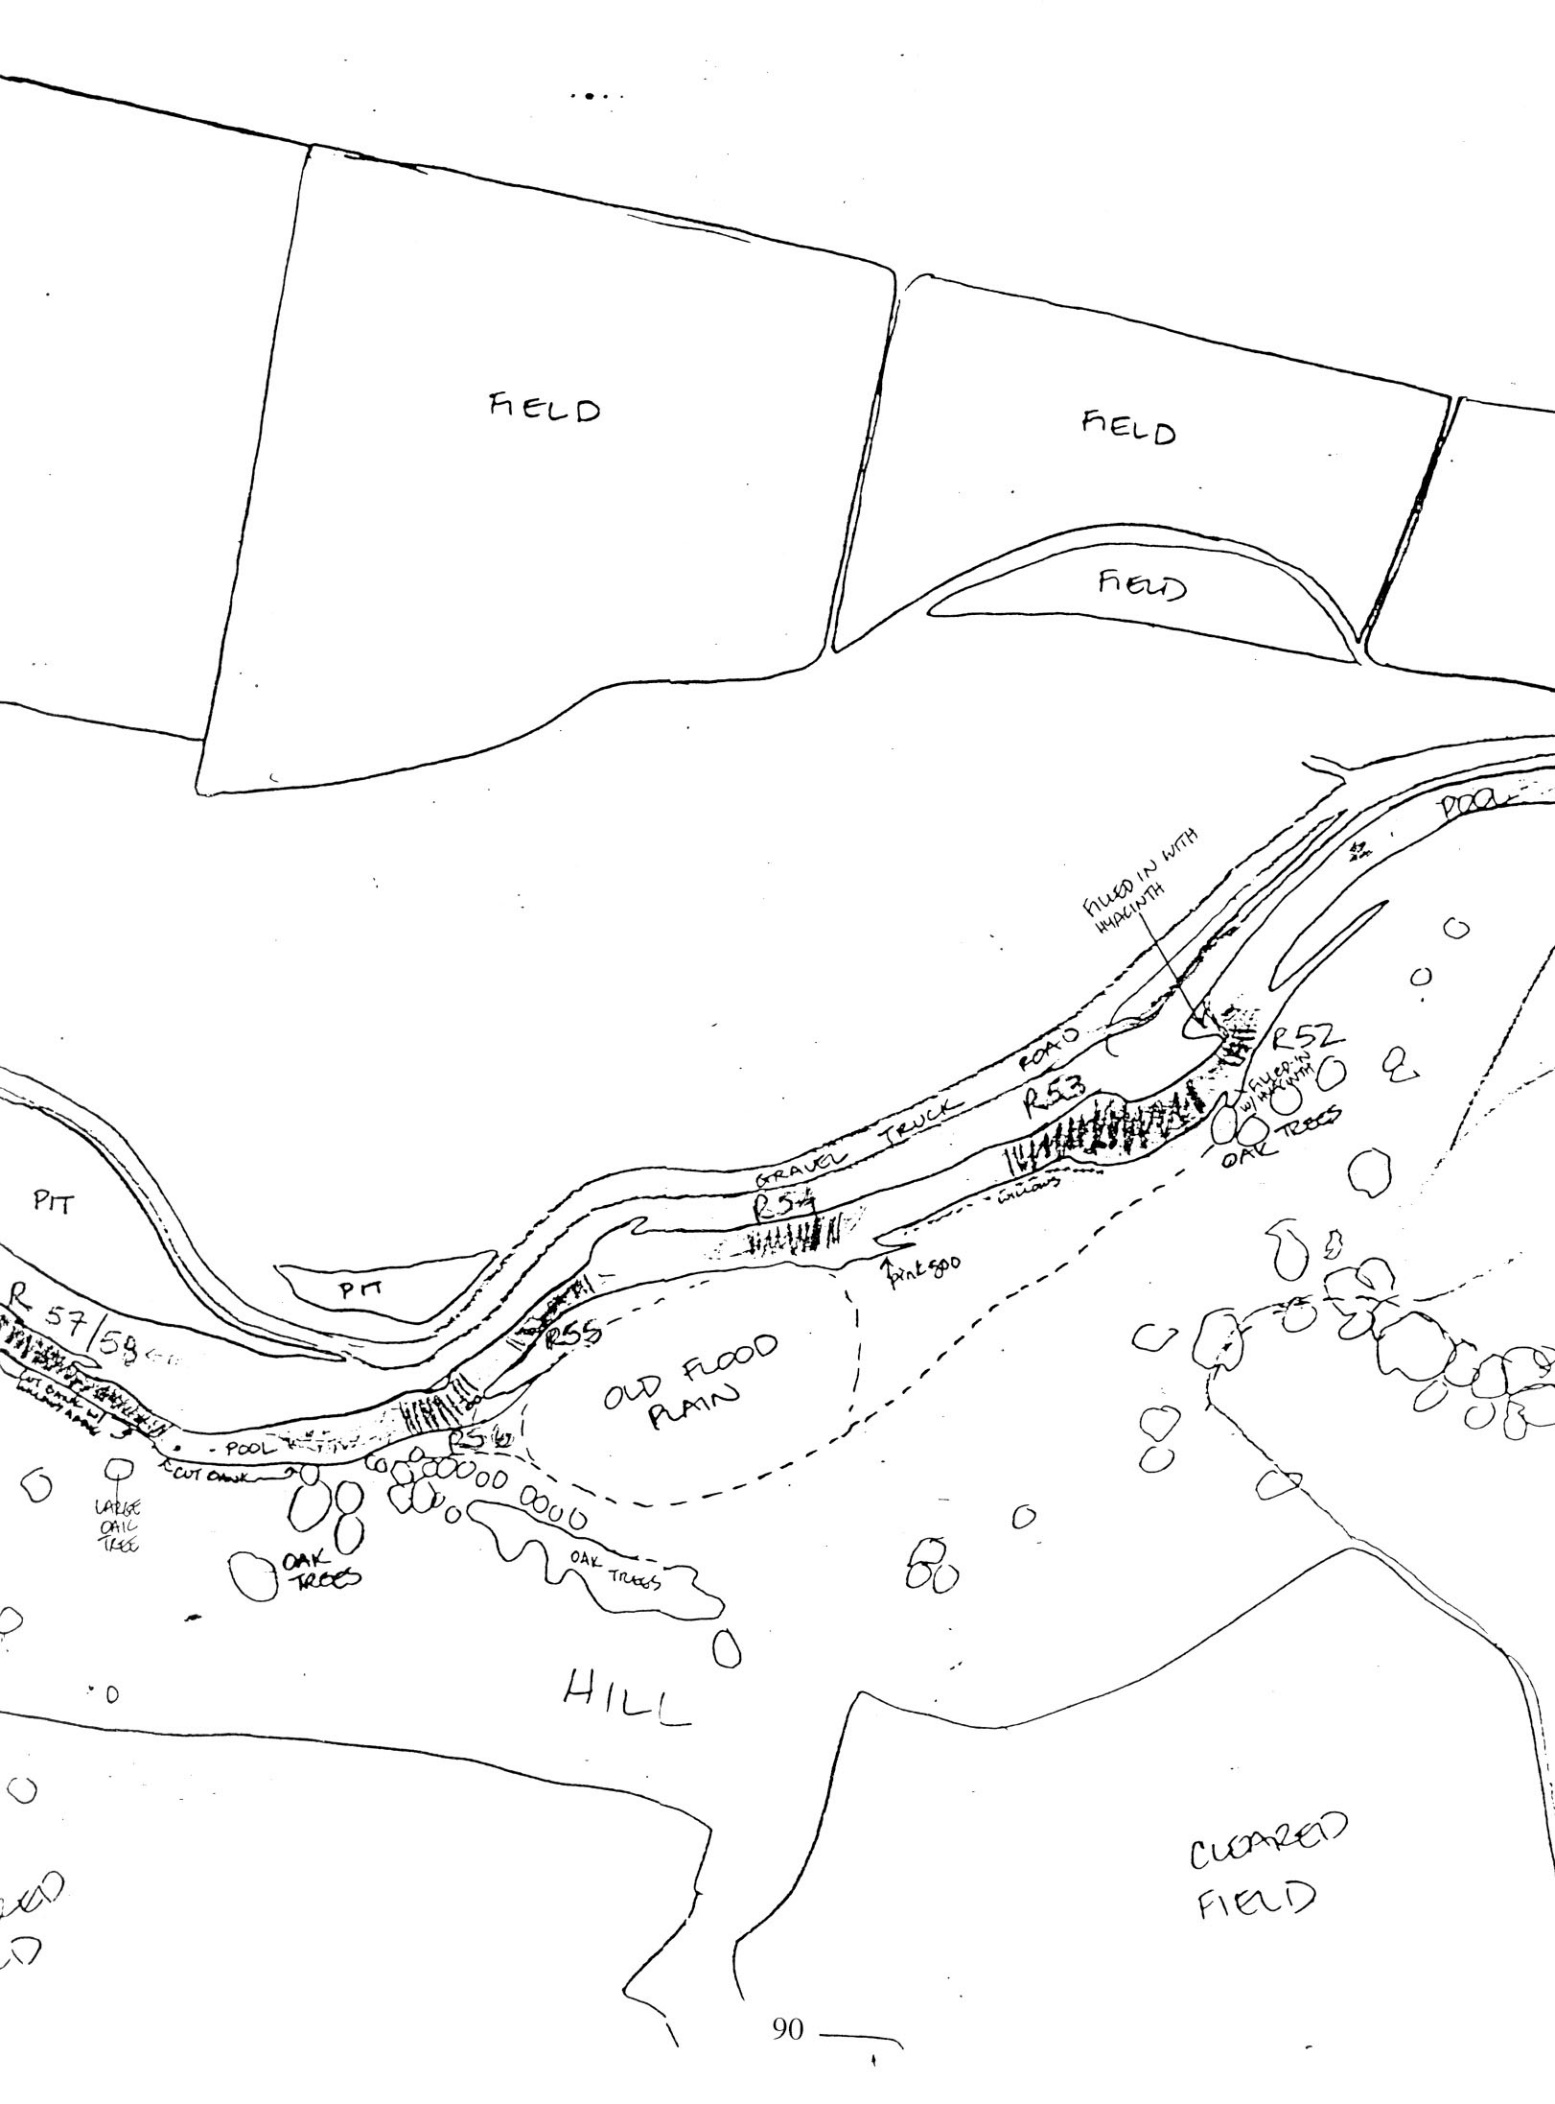
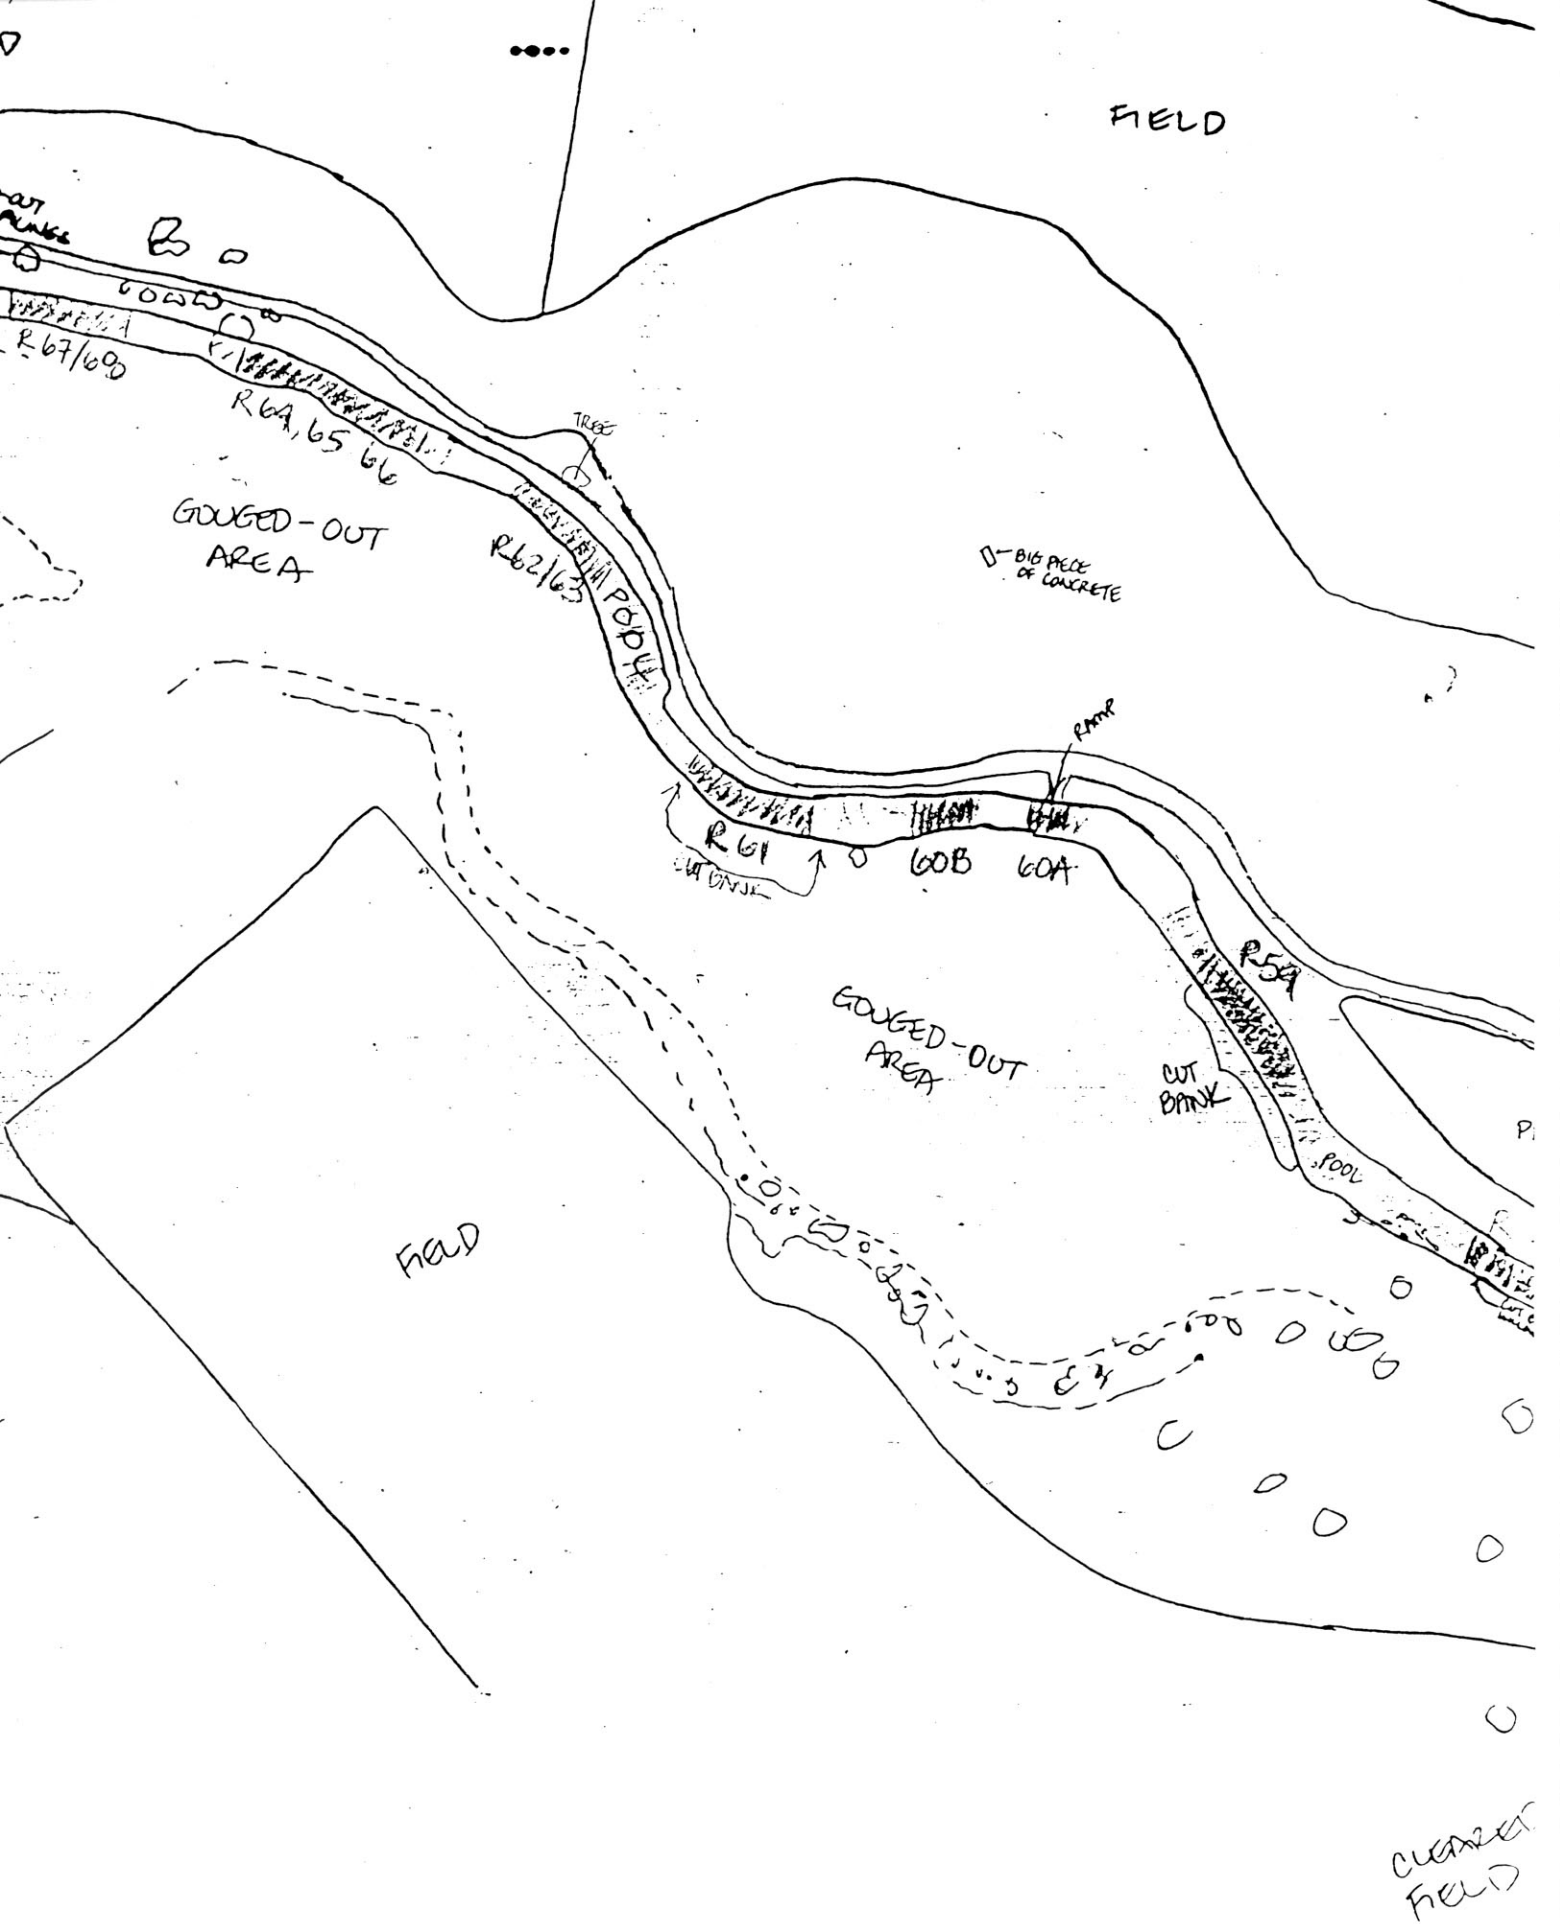
**Merced River**  
**Miles 42.7-45.5**  
**Riffles 41-44, 47-50, 54-58, and 64-66**

This 2.8-mile reach of the Merced River is fairly similar. There is continuous, small-size riparian vegetation along both banks. The channel is approximately 75 feet wide. The reach has good velocities, good drops, easy access, and poor substrate material. Restoration would involve excavating the large, armored cobble and replacing it with graded, washed spawning gravel.

Sixteen individual riffles were identified for potential restoration within this reach. These riffles could be constructed as one large job or in smaller groups. There are four riffle groups ranging from 500 to 800 feet long.

There is cattle grazing along almost all of the south bank in this reach. Cattle grazing tends to damage and inhibit growth of riparian vegetation. In addition, cattle grazing right down to the river causes excessive erosion that can quickly silt in clean gravel. The landowner has expressed a willingness to work with us. He has proposed rotating his cattle so that they are not near the river during spawning season. This will help to some extent, but in the long run any excessive erosion will be detrimental.

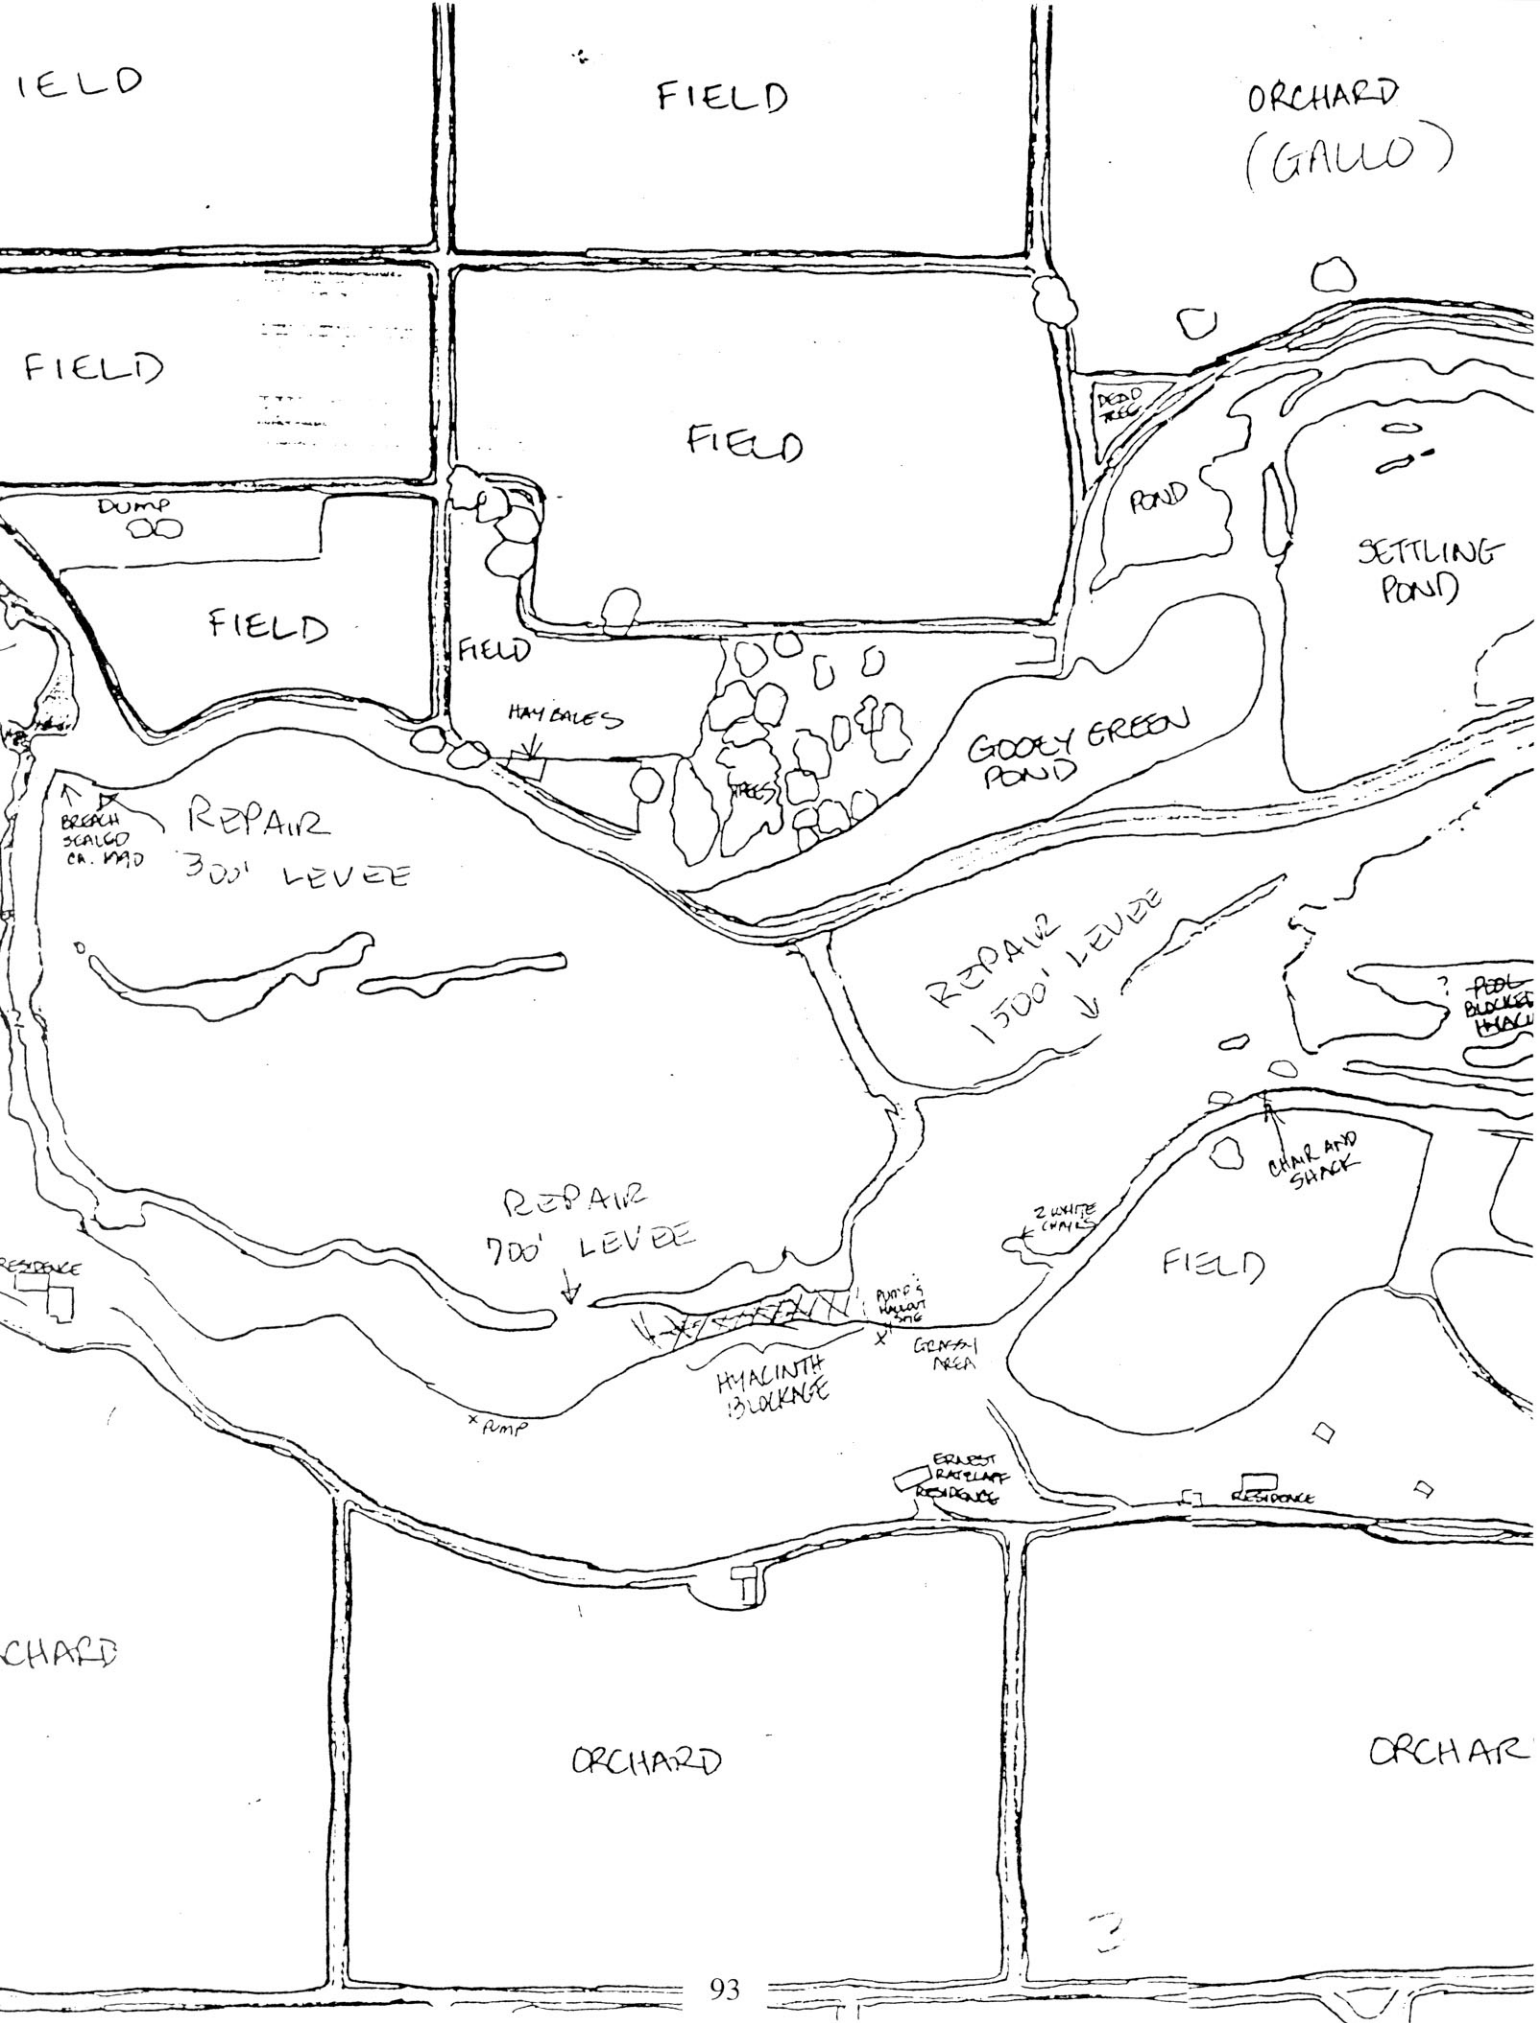
## **Merced River Mile 40.1-40.5**

Approximately 200 acres of abandoned gravel pits have breached, and the river now passes through them. These pits provide prime habitat for predators of out-migrating salmon smolts.

Restoration would involve isolating the pits from the channel. Repairs to the levees are relatively minor in comparison to the large amount of predator habitat that could be isolated. Three breaches totaling approximately 2,500 feet would need to be sealed.
